I see a strange saw tooth type of pattern in the UV baseline using my Cogent HPLC column what is it and how can I fix it - FAQ

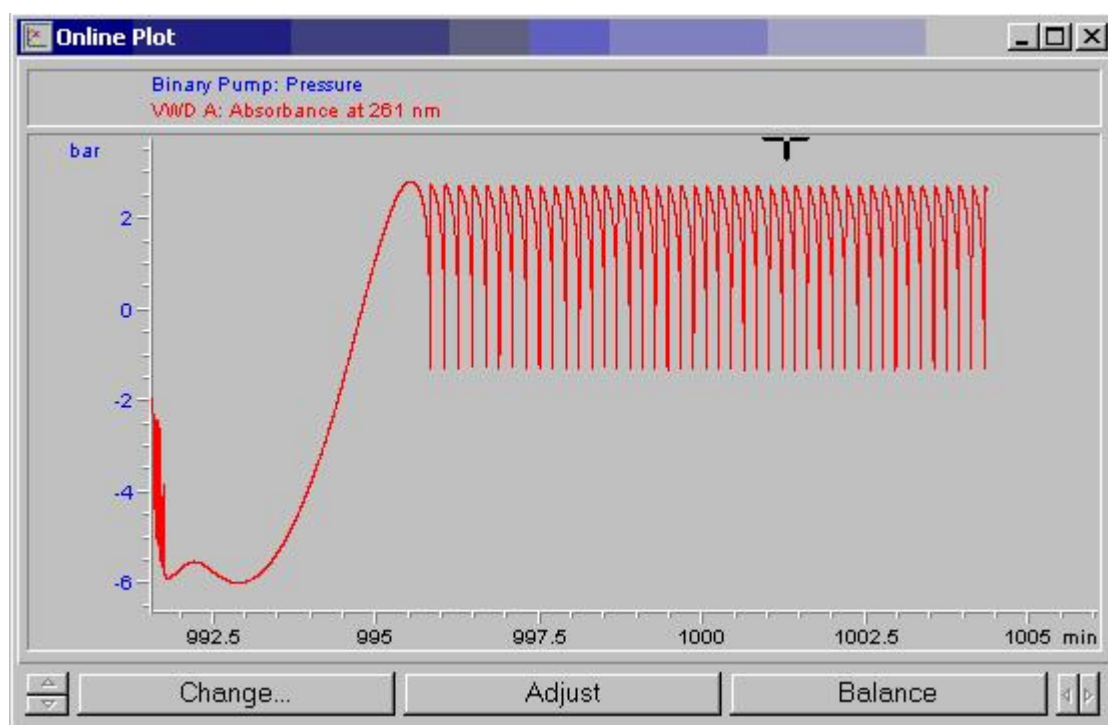
**This may be due to the presence of an immiscible solvent remaining in the column.**

Even trace amounts of these solvents can cause issues. The immiscibility manifests as an unstable baseline, such as the example shown below. In order to fix this issue, try flushing the column overnight with a mutually miscible solvent such as isopropanol to remove any immiscible non-polar solvents that may be in it.

This phenomenon can happen to Cogent TYPE-C™ columns or others columns that may have been introduced to immiscible solvents. In some cases, you might observe this with a new column if residual packing solvents may still be present.
